UNDERGROUND INJECTION CONTROL
INSPECTION REPORT

Purpose: Permit Compliance Evaluation

Facility: SWD Specialties, LLC of Kalkaska, Michigan;
Hogerheide #1-29 SWD,
Wlosinski #2-27 SWD, and
Simpson #1-9

EPA UIC Permit Number(s): MI-079-2D-C001
MI-079-2D-C016, and
MI-079-2D-C008

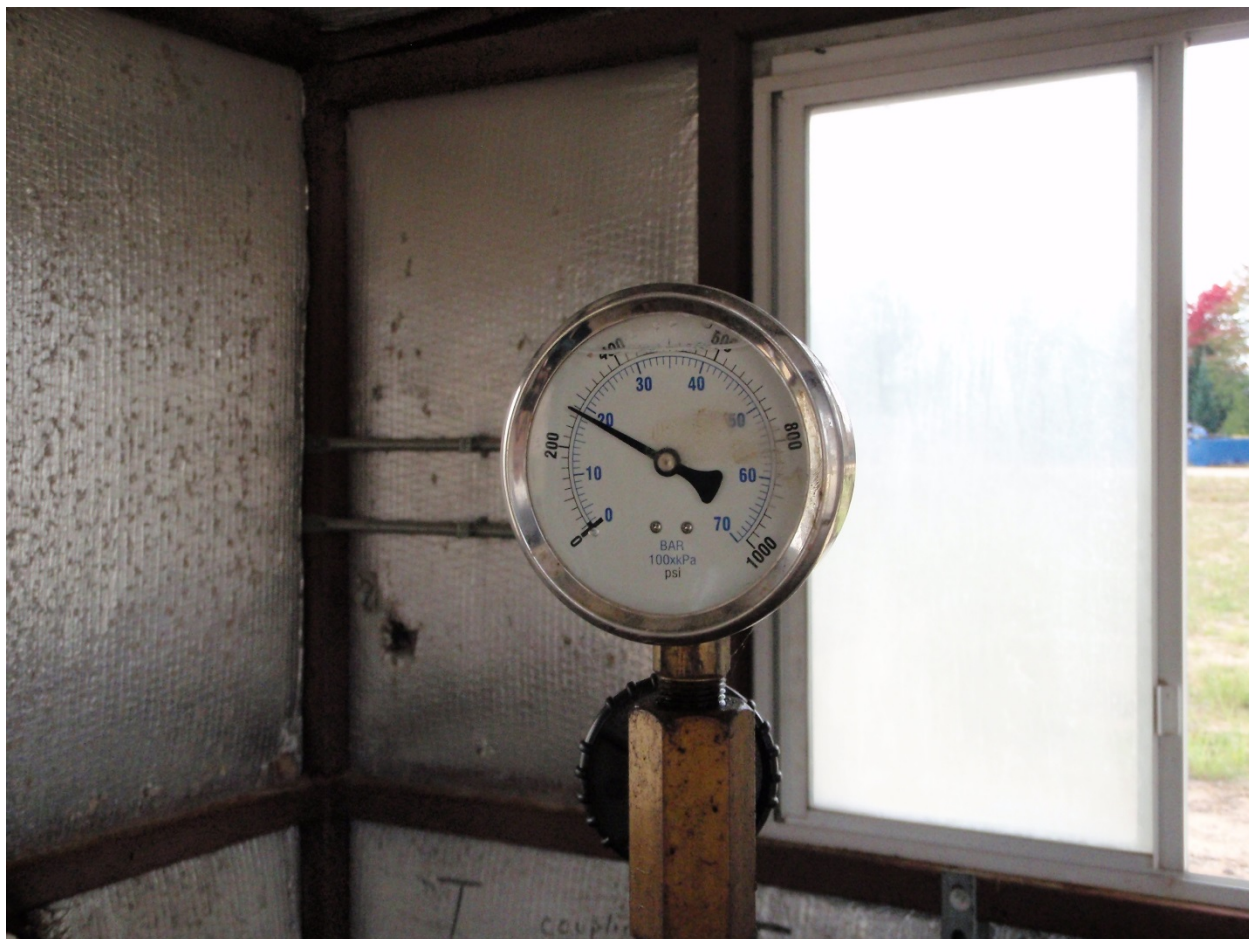
Figure 1: P9250044, 9/25/14, 9:25 am (Eastern), Hogerheide #1-29 SWD tubing gage (EPA observed 280 psig on gage while injecting), wellhead located in enclosure building, facing south/southwest.

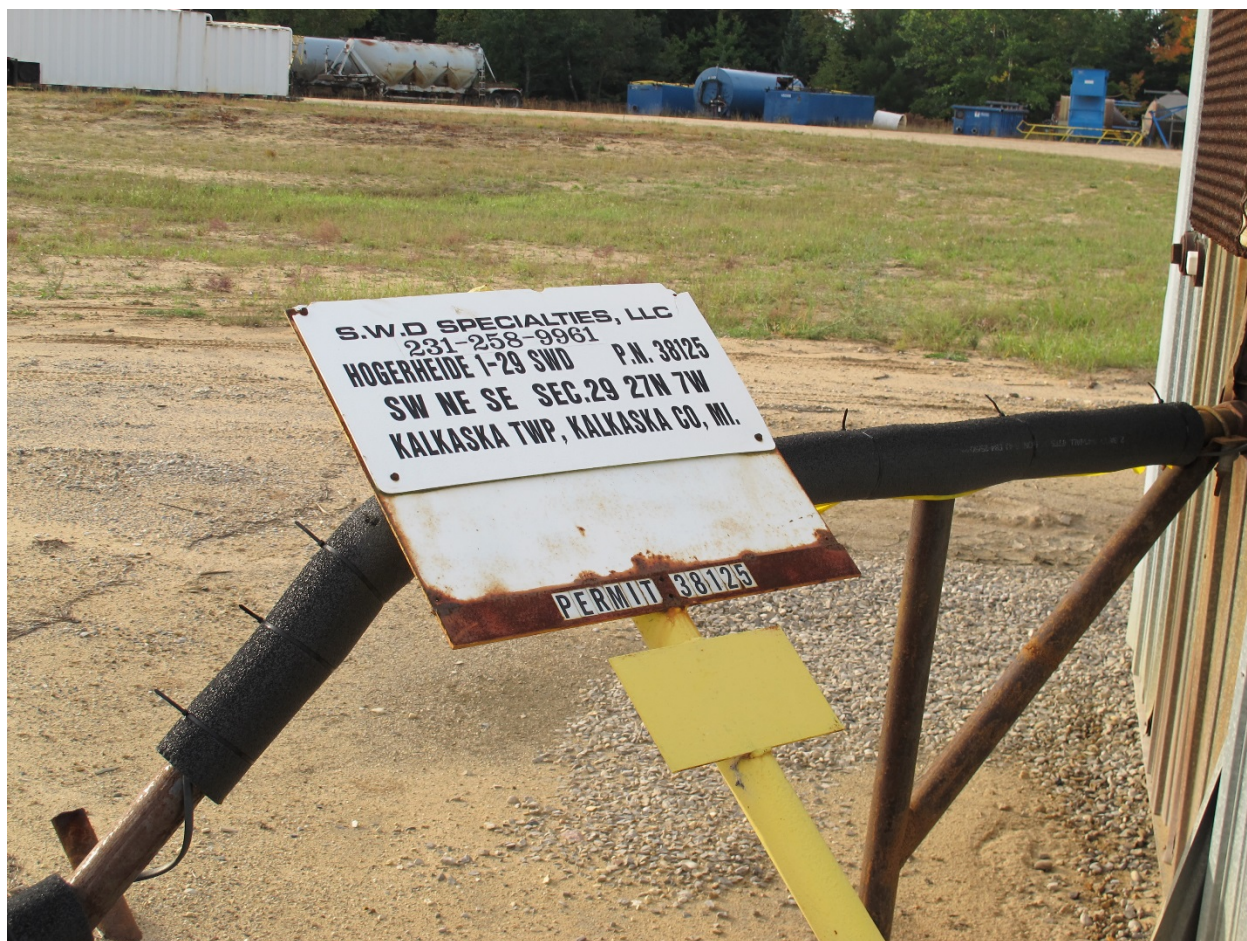
The Hogerheide #1-29 SWD facility entrance is located on the west side of M-66 Highway, in Kalkaska County. The facility is fenced and gated. Mr. Kniss indicated it is typically locked and all of the facility's truck drivers have a combination to the lock, and the Company has plans to upgrade site security and install cameras. The well pad consists of a sand base, and is completely surrounded by perimeter fencing. The wellhead is covered by a small steel enclosure building. Gages are present on the tubing and annulus, and appeared to be in good working condition (Attachment B, Figures 1 and 3). EPA observed 280 pounds per square inch gaged (psig) on the tubing, and 68 psig on the annulus. Staff at the facility monitor injection and annulus pressure by manually recording gage pressures. The annulus to the well is closed, and liquid loss is monitored on a quarterly basis. A sign identifying the well was mounted on a steel post; leaning on piping next to the well enclosure building (Attachment B, Figure 2).

Figure 2: IMG_0261, 9/25/14, 9:32 am (Eastern), Hogerheide #1-29 SWD well pad and sign, facing south.

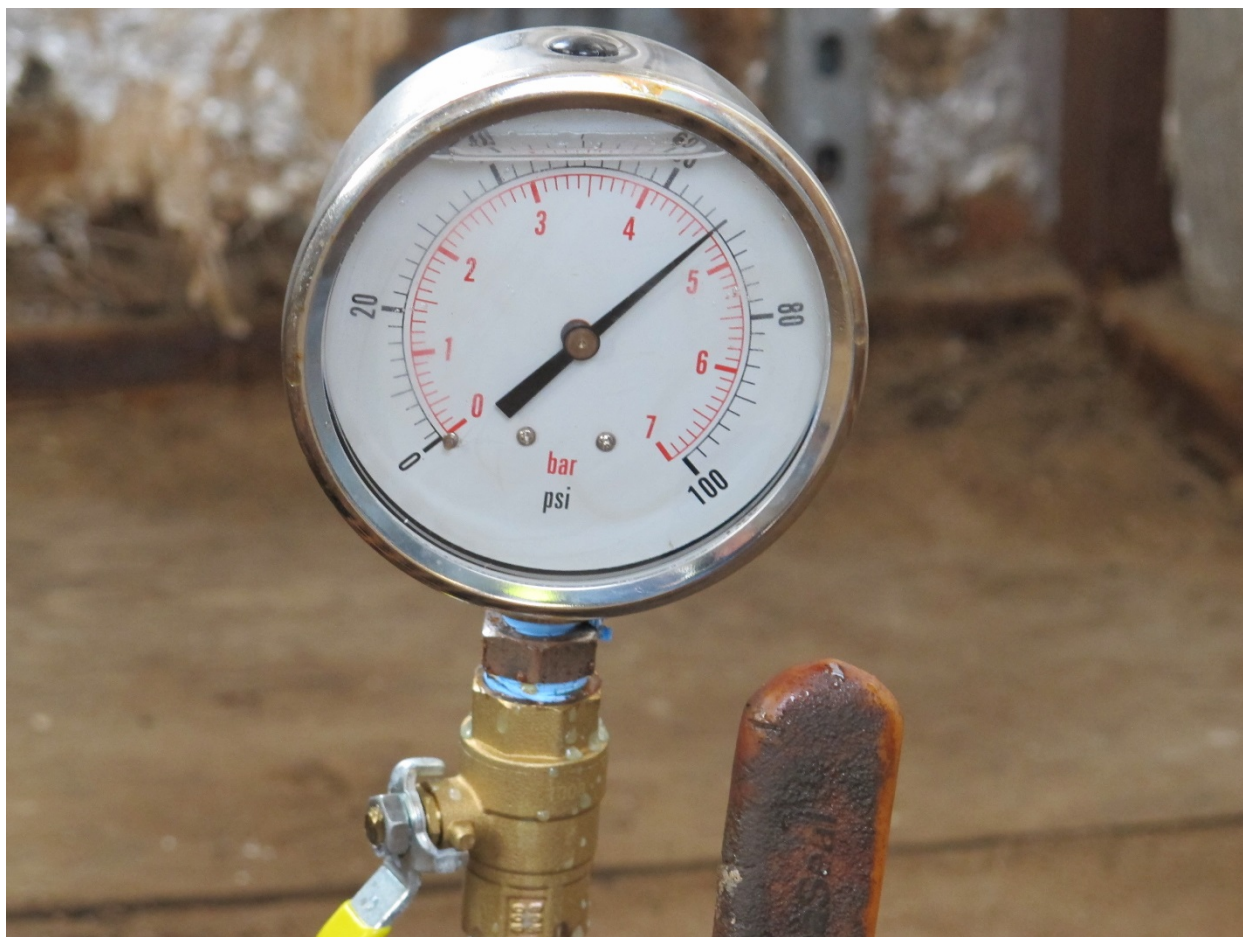
Figure 3: IMG_0263, 9/25/14, 9:35 am (Eastern), Hogerheide #1-29 SWD annulus pressure gage (68 psig observed), facing south.

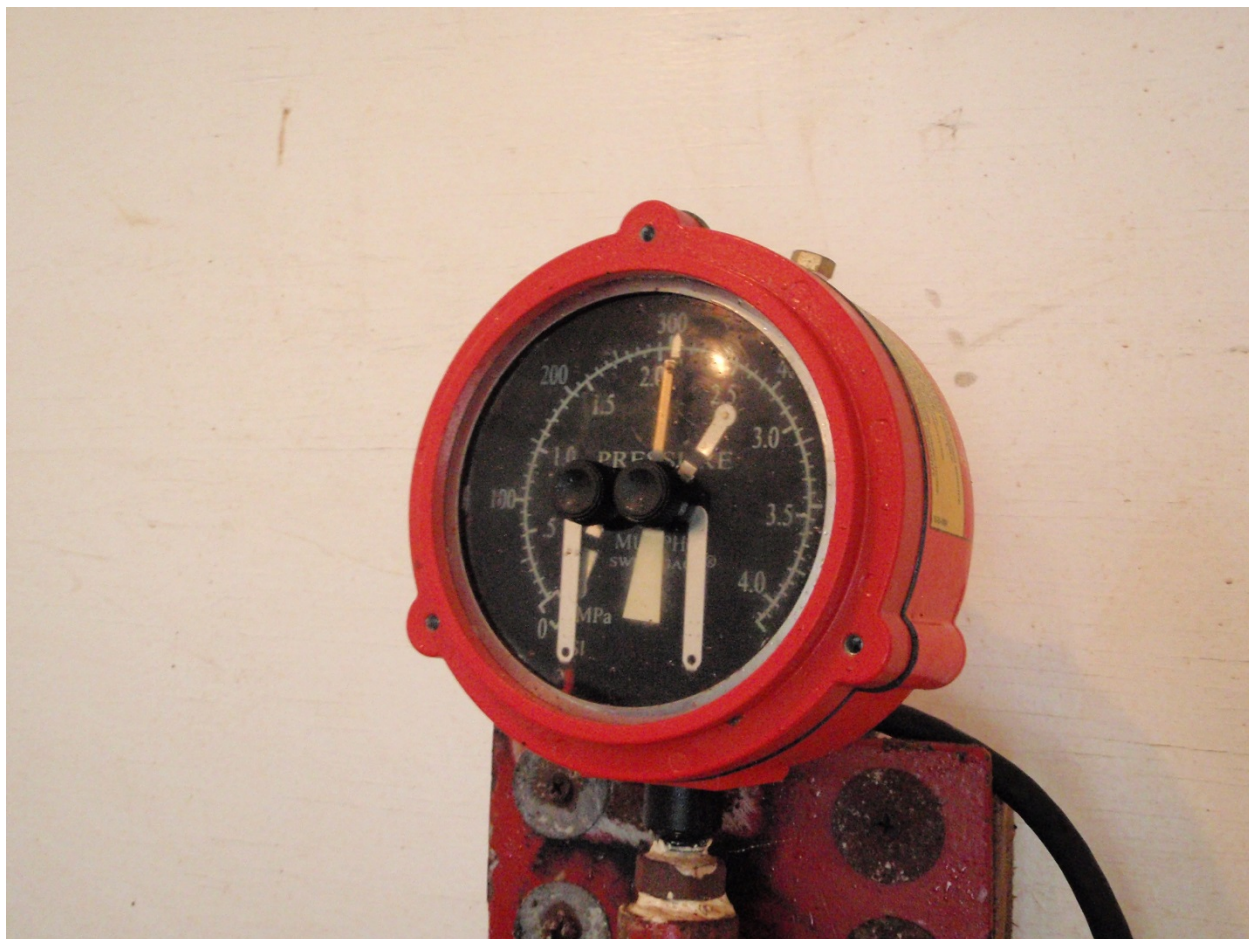
Figure 4: P9250045, 9/25/14, 9:32 am (Eastern), Hogerheide #1-29 SWD pump house, Murphy Pressure Switchgauge (300 psig observed on gage), facing south/southwest.

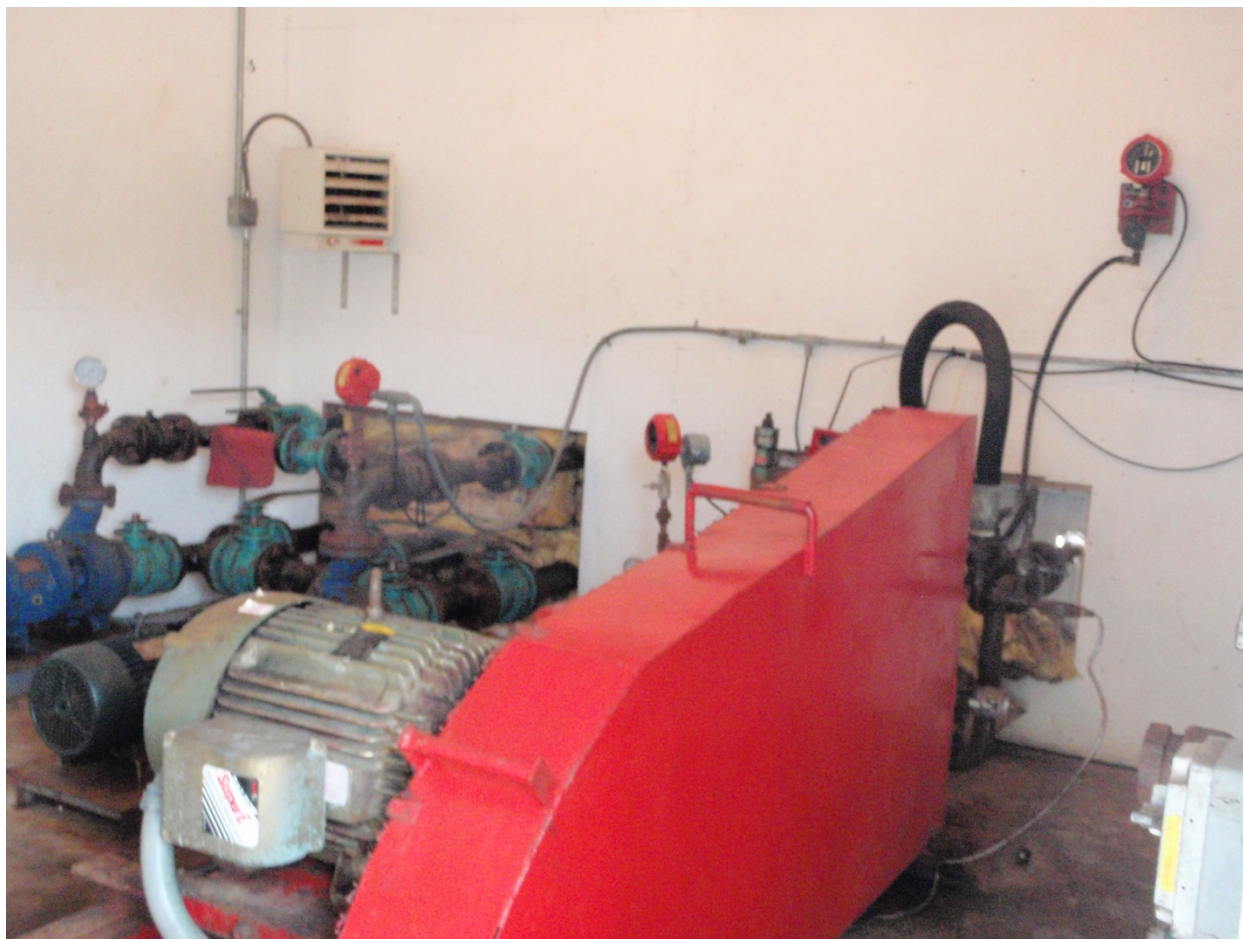
Figure 5: P9250046, 9/25/14, 9:37 am (Eastern), Hogerheide #1-29 SWD pump house, pumps used for injection are activated/shut off by Murphy Pressure Switchgates, facing south.

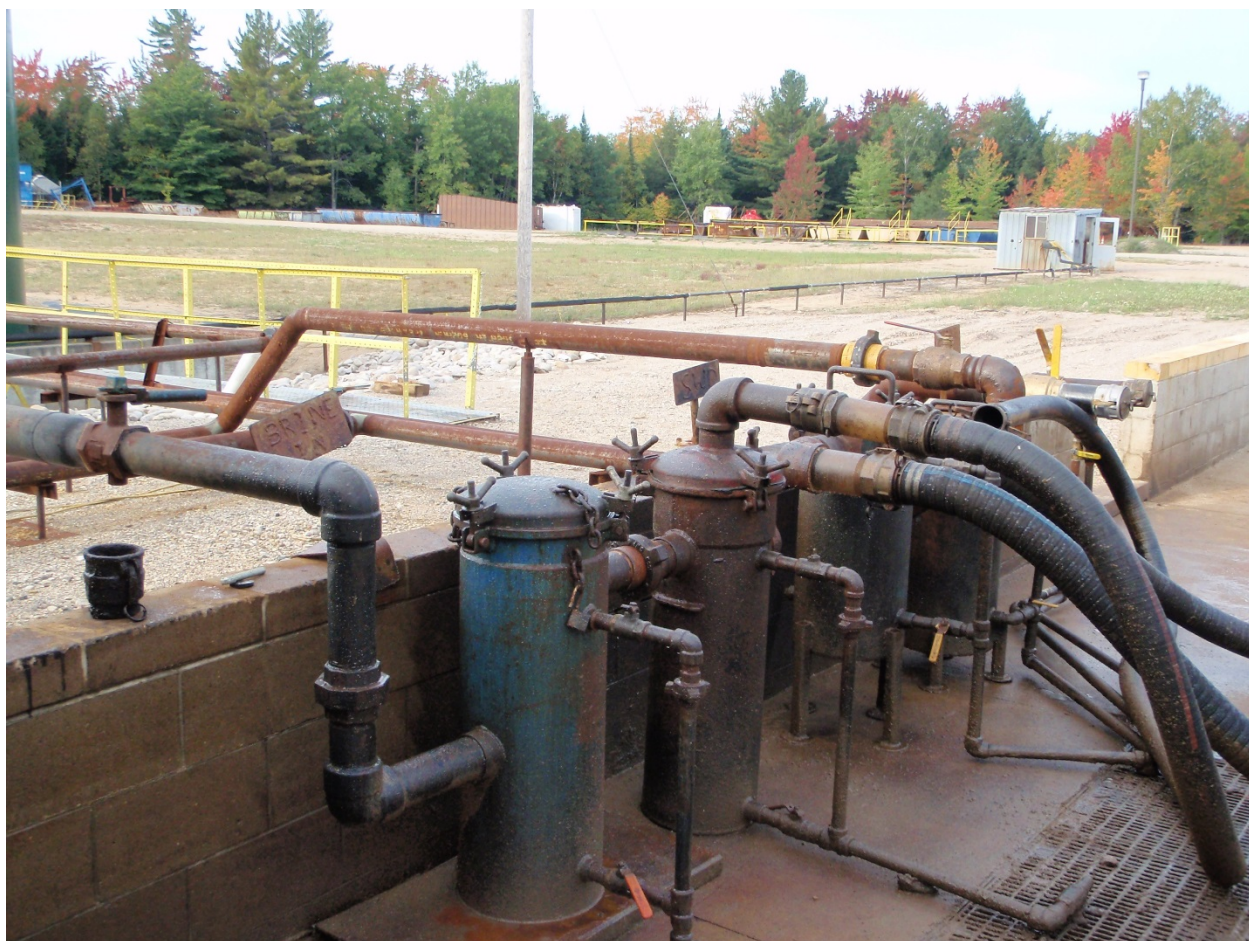
lines, filter canisters to remove solids, and a vaulted trap to catch spills. (Attachment B, Figures 6 – 7, 10). Grease and oil residue are present on flow line hoses and filter canisters. All solids recovered in the on-site traps and filter cartridges are landfilled by the Company. A sign posting operating procedures for unloading and loading fluid at the facility, including emergency contact information, is posted on the pump house at the load station (Attachment B, Figure 8).

Figure 6: P9250047, 9/25/14, 9:37 am (Eastern), Hogerheide #1-29 SWD offload station, in-line filter canisters and vaulted spill catch present, hoses and cement pad appeared oily, facing southwest.

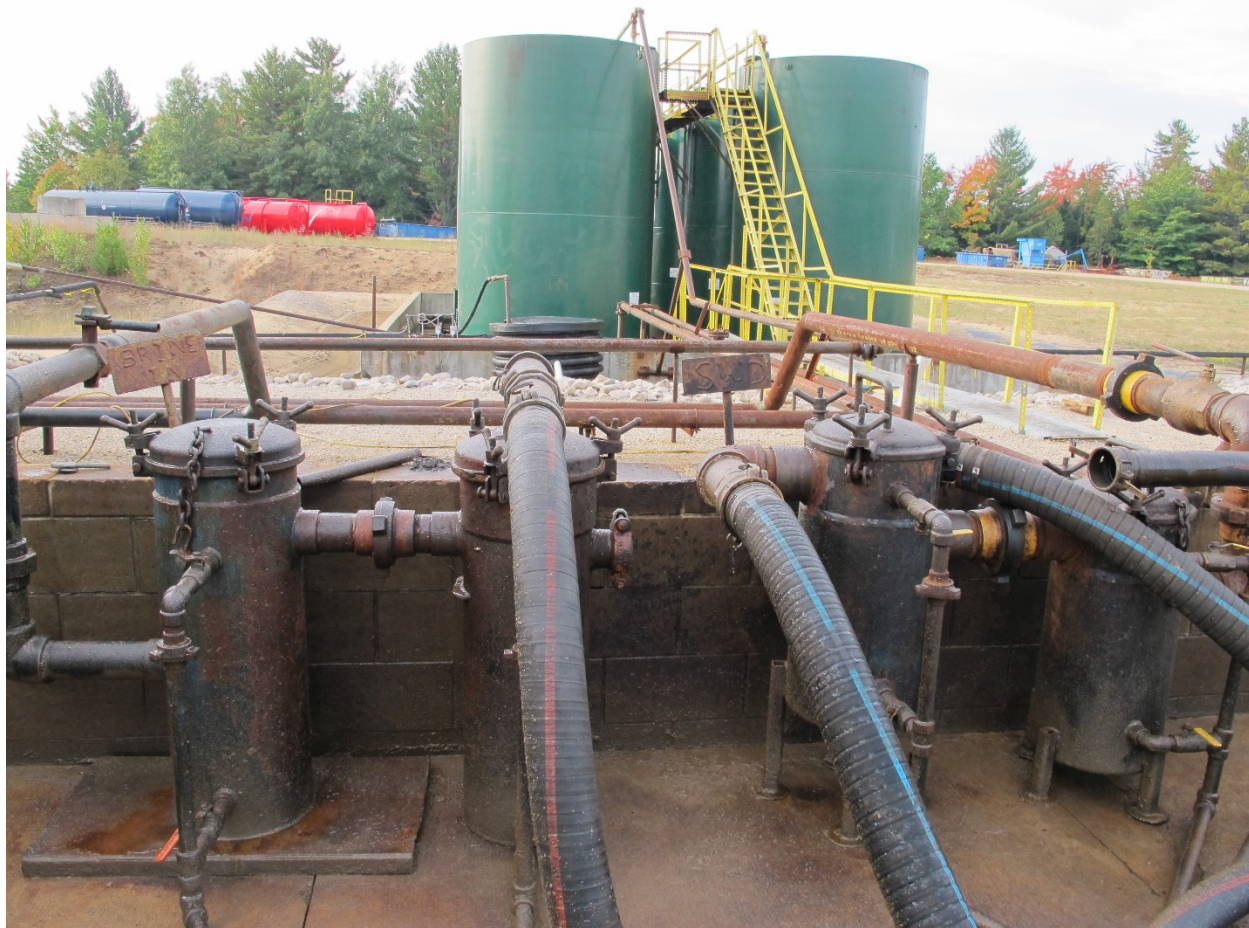
Figure 7: IMG_0265, 9/25/14, 9:41 am (Eastern), Hogerheide #1-29 SWD offload station, in-line filter canisters, tank battery and secondary containment, facing south.

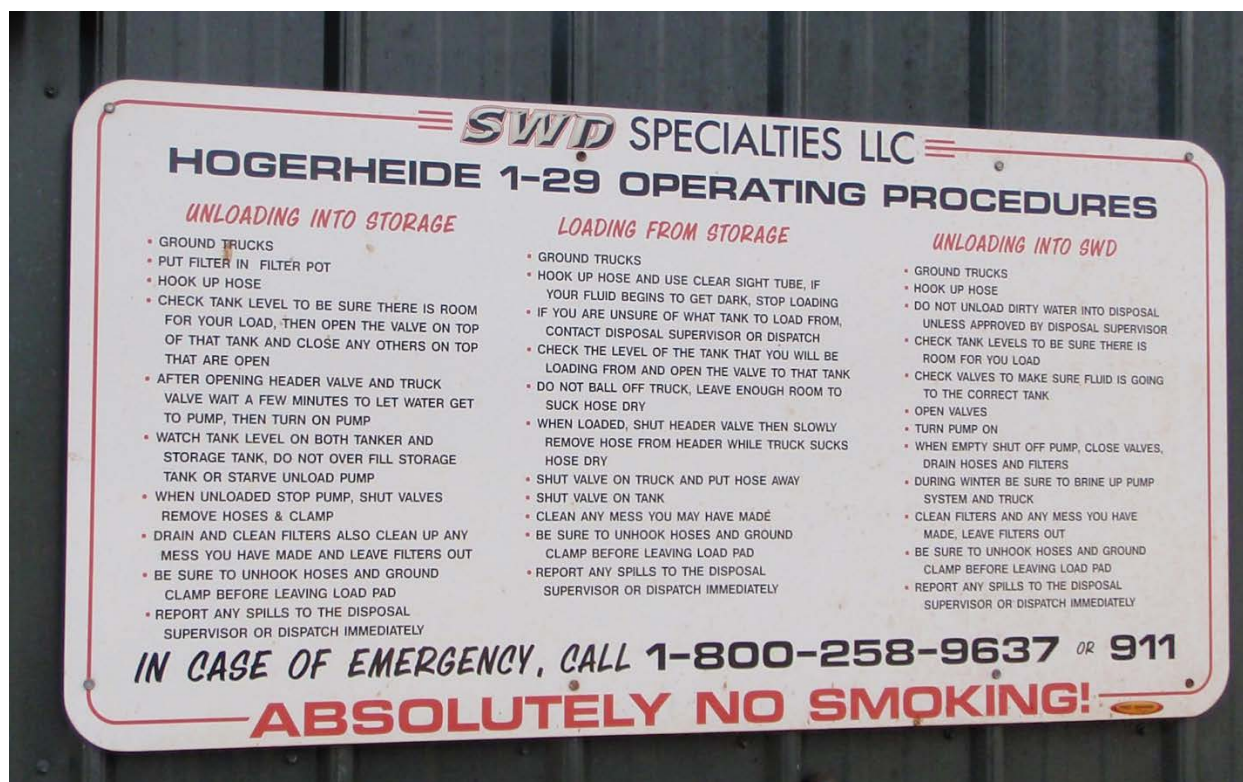
Figure 8: P9250048, 9/25/14, 9:41 am (Eastern), Hogerheide #1-29 SWD operation procedure sign posted at offload station and pump house, facing south.

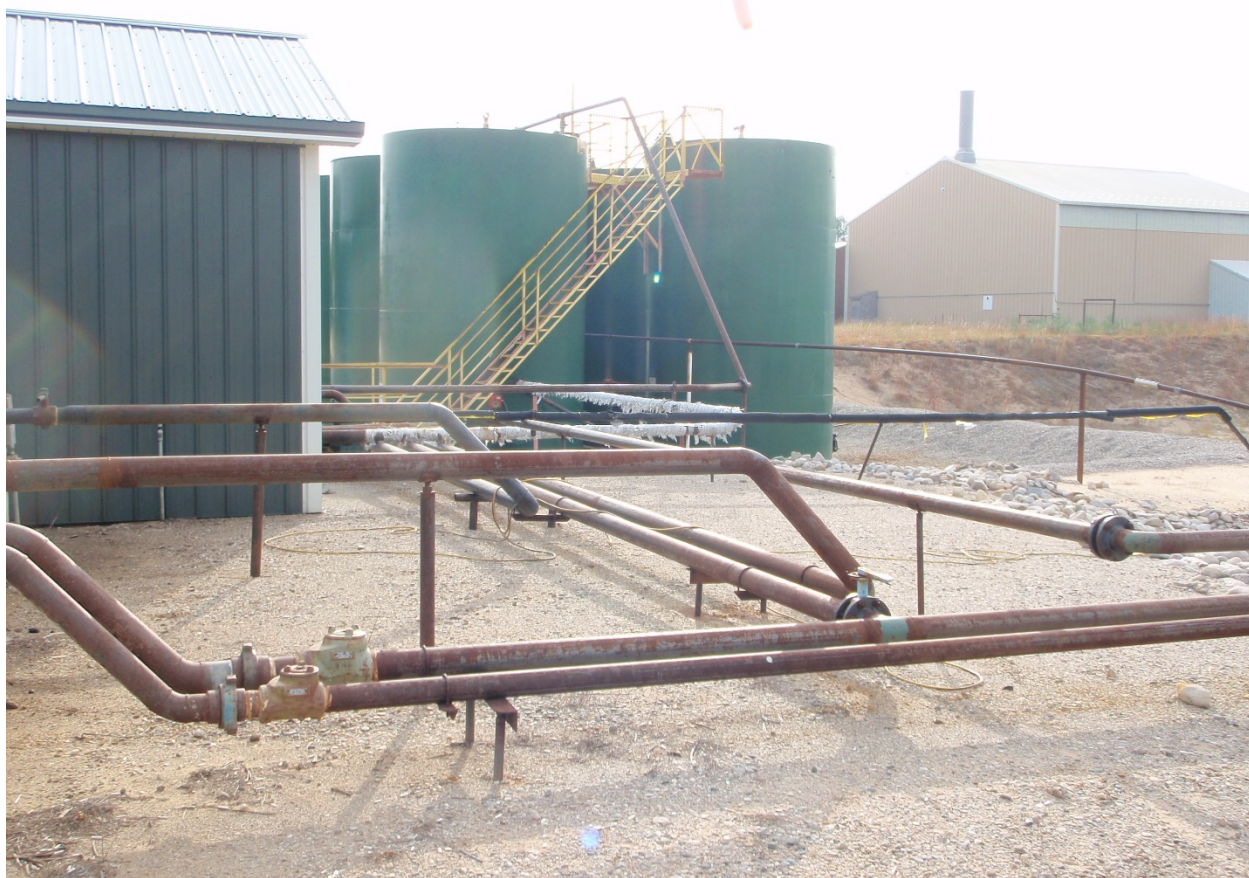
All injection into the well takes place with the use of a pump, and a Murphy Pressure Switchgauge (mechanical gage instrument) starts or stops injection, and limits the injection pressure at which the well can operate. Mr. Kniss stated SWD typically sets its Murphy Switchgages 10 – 20 psig below the EPA permitted maximum injection pressure (MIP). The permitted MIP is limited to 399 psig at the surface of the Hogerheide #1-29 SWD. EPA observed 300 – 310 psig on the Murphy Switchgauge located in the pump house for the Hogerheide #1-29 SWD well (Attachment B, Figures 4 and 5). Both the Murphy Switchgauge and a "tank overflow alarm" act as an automatic shut-off system at the facility. Mr. Kniss stated that the volume of fluid injected and flow rate are based on the fluid level in the facility's brine tanks and the fluid drawdown. Two lined secondary containment areas each house six 400 bbl brine tanks (12 total). All piping from the brine tanks to the injection well was in good condition; no signs of leaks were present (Attachment B, Figure 9).

Figure 9: P9250049, 9/25/14, 9:50 am (Eastern), Hogerheide #1-29 SWD aboveground piping, pump house, tank battery and secondary containment, facing southeast.

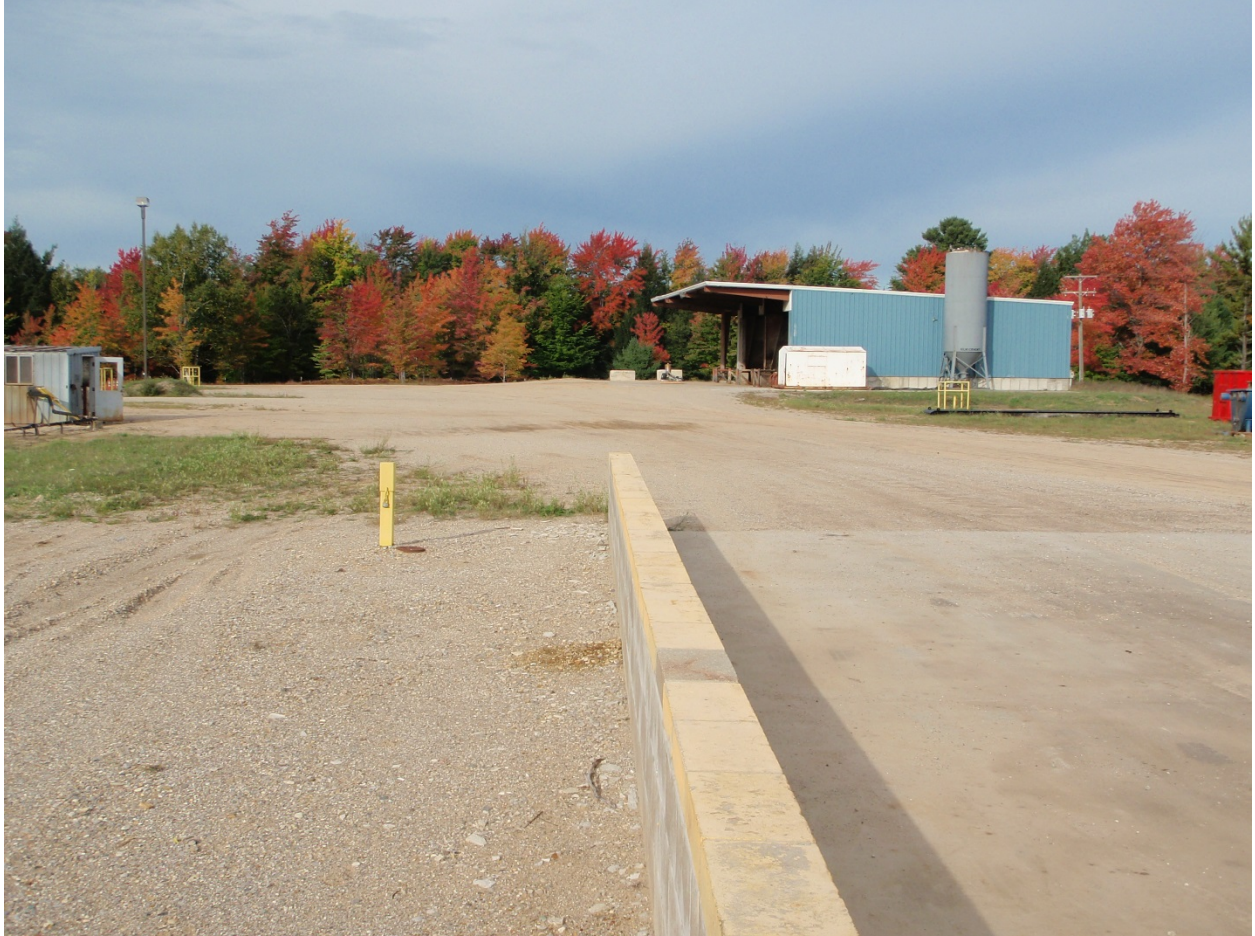
Figure 10: P9250051, 9/25/14, 9:50 am (Eastern), Hogerheide #1-29 SWD well enclosure building (left), and offload pad (right), facing west.

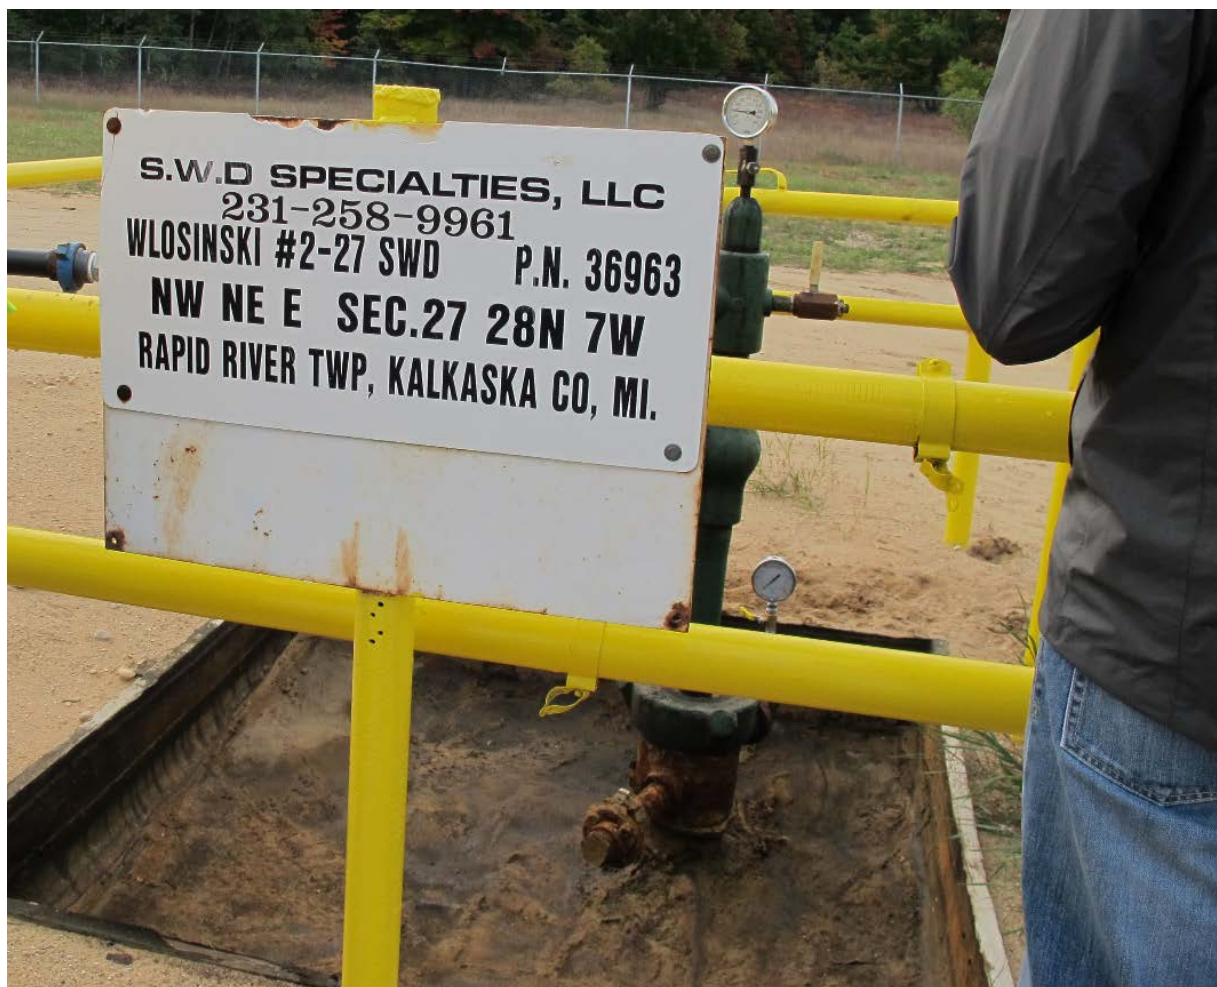
Gages are present on the tubing and annulus, and appeared to be in good working condition (Attachment B, Figures 11 - 13). EPA observed 350 psig on the tubing, and 2 psig on the annulus while the well was injecting. The EPA permitted MIP of the Wlosinski #2-27 well is limited to 503 psig at the surface. Injection and annulus pressures at the well are manually recorded by SWD staff. The annulus is closed, and liquid loss is monitored on a quarterly basis. The annulus is filled with brine and corrosive inhibitor. A sign identifying the well is posted at the wellhead (Attachment B, Figure 11).

Figure 11: IMG_0266, 9/25/14, 10:37 am (Eastern), Wlosinski #2-27 wellhead and sign, small secondary containment area, gages present on tubing and annulus, facing south.

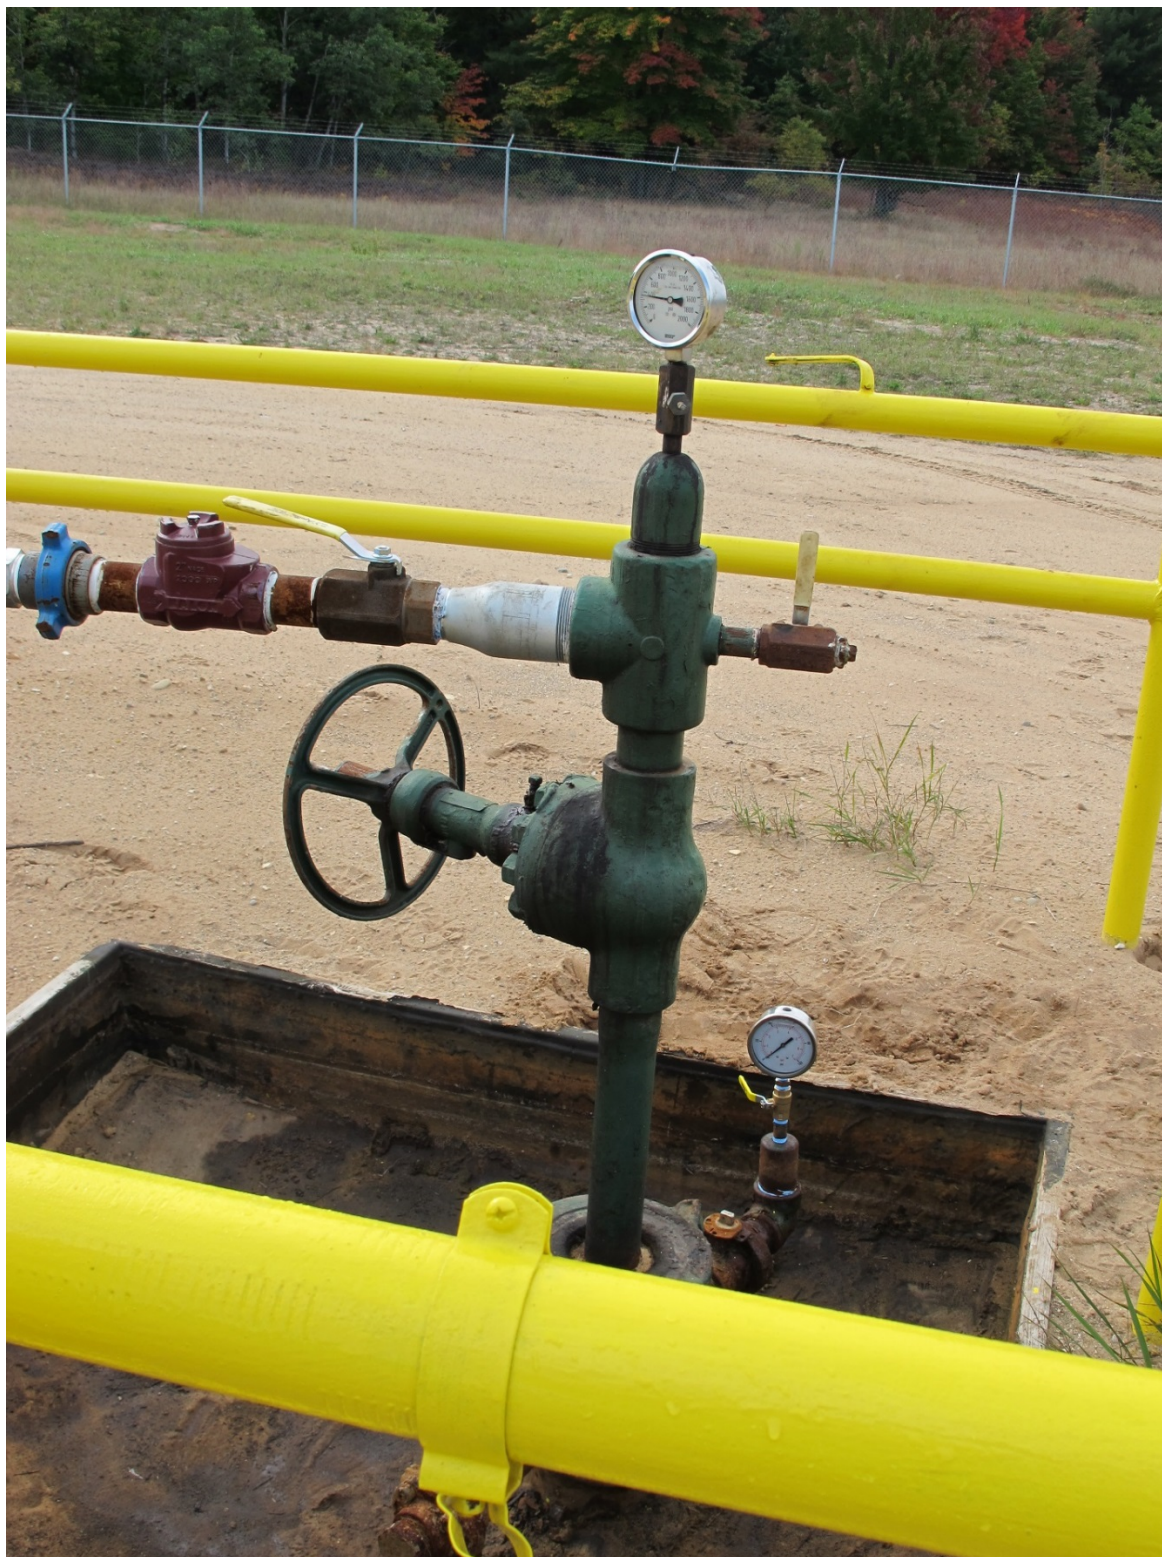
Figure 13: IMG_0268, 9/25/14, 10:38 am (Eastern), Wlosinski #2-27 wellhead and pad, no sign of spills or leaks were observed, tubing and annulus gages present and appeared in good working condition, facing south.

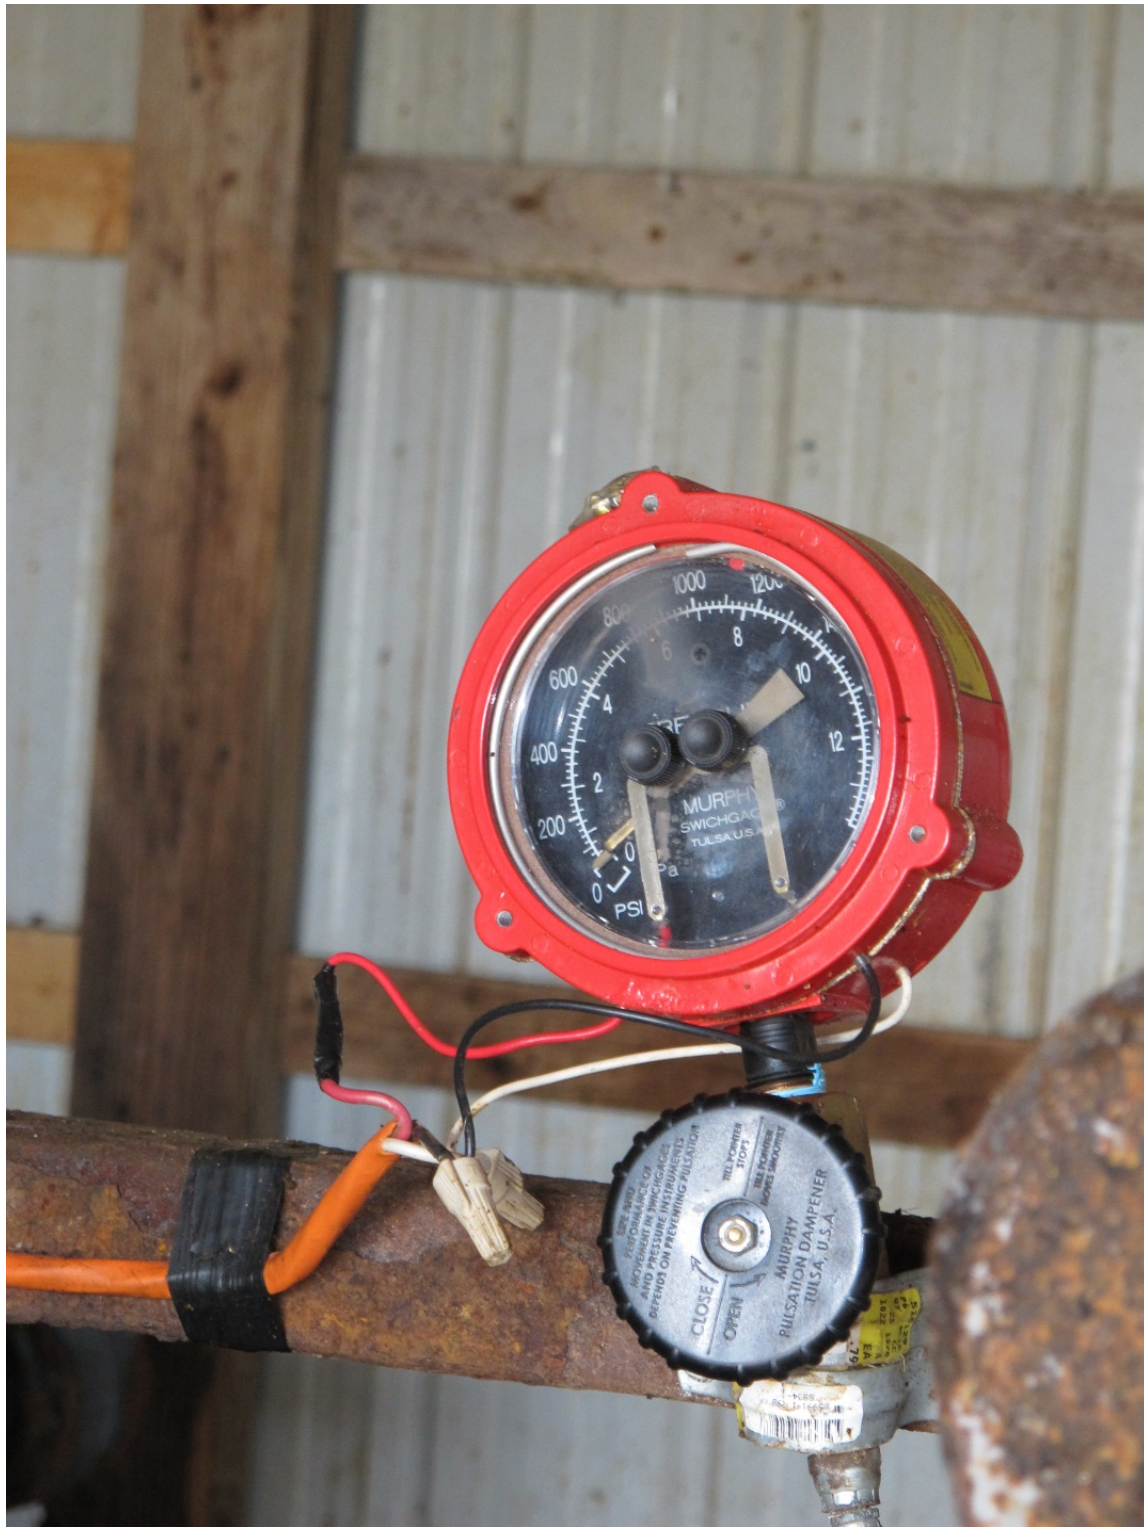
Three Murphy Pressure Switchgages are used to start/stop and limit injection pressure at the Wlosinski #2-27 facility (e.g. Attachment B, Figures 14 and 15). Mr. Kniss stated that the volume of fluid injected and flow rate are based on the fluid level in the facility's brine tanks. The tank battery is completely within a lined secondary containment/berm area. Seven 400 bbl brine tanks are used to store injection fluid (Attachment B, Figure 16). Aboveground steel piping was recently painted and is supported by steel stands. All piping appeared in good condition; no signs of leaks were present (Attachment B, Figure 9). EPA inspectors followed Mr. Kniss' vehicle to the Simpson #1-9 injection well facility at 11:00 am (Eastern).

Figure 14: IMG_0272, 9/25/14, 10:45 am (Eastern), Wlosinski #2-27 pump house, Murphy Pressure Switchgauge instrument (mechanical pressure gauge) used to start and stop injection.

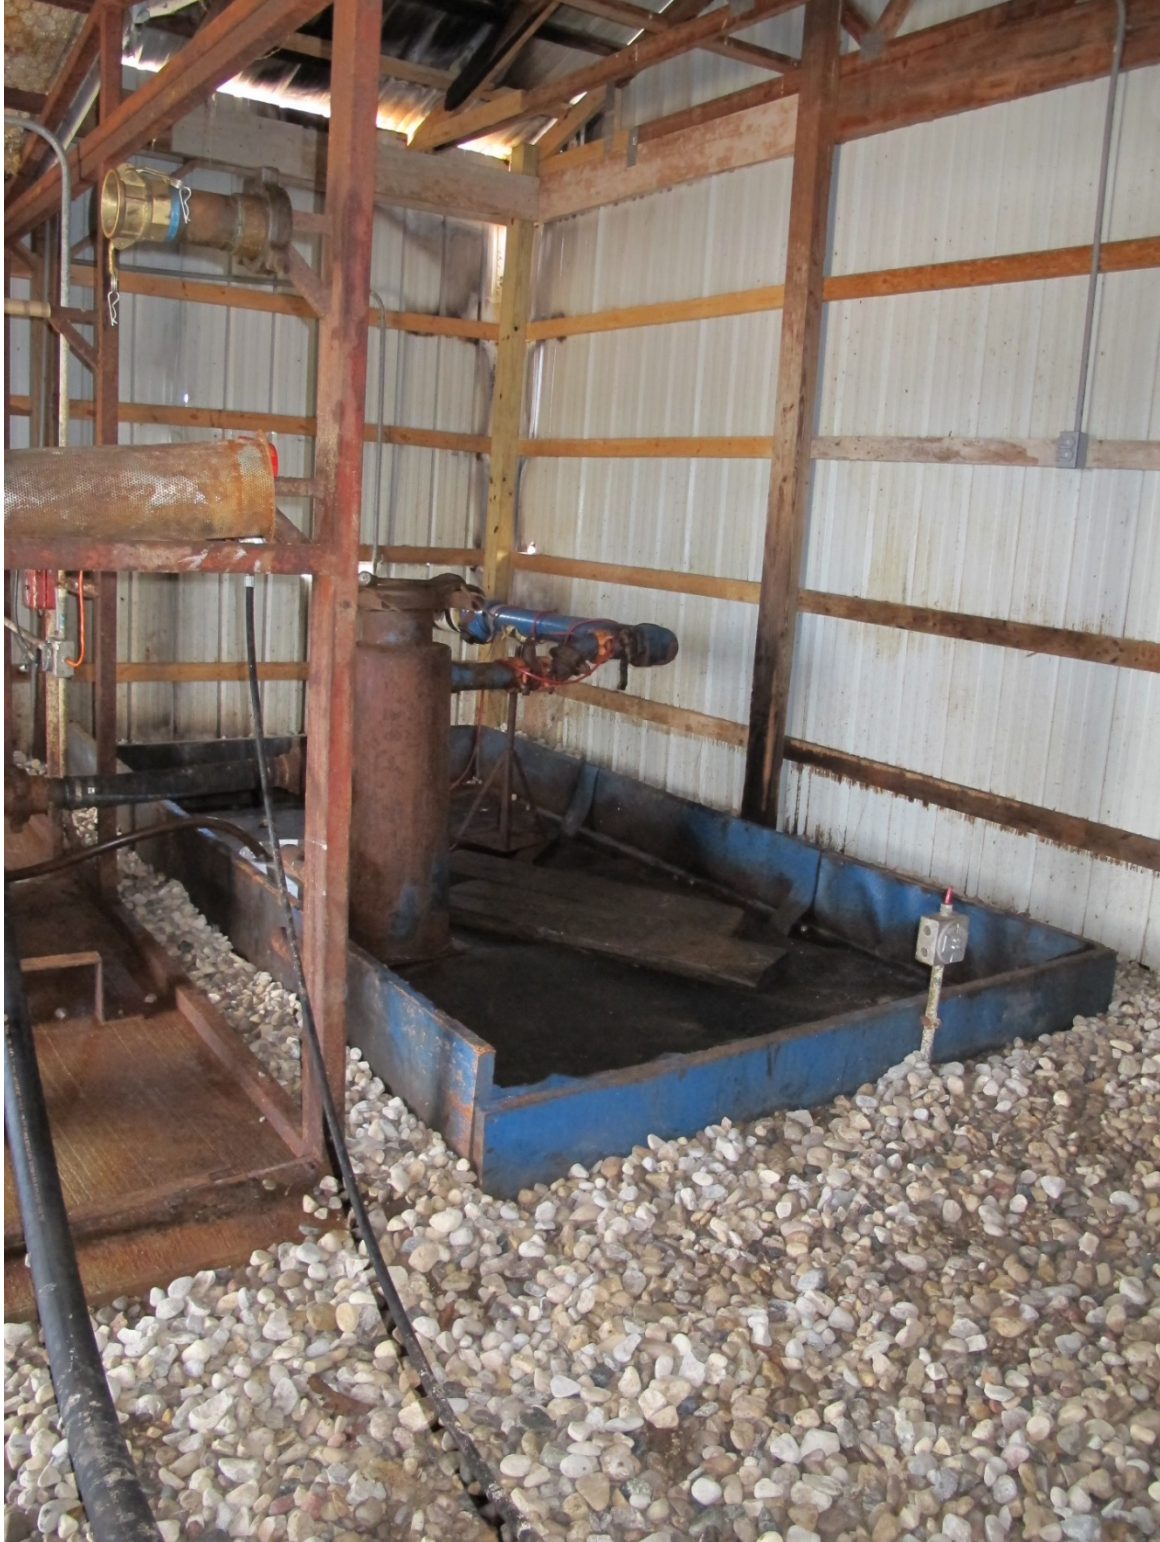
Figure 15: IMG_0273, 9/25/14, 10:46 am (Eastern), Wlosinski #2-27 pump house, Murphy Pressure Swichgauge, filter canisters, and secondary containment catch present.

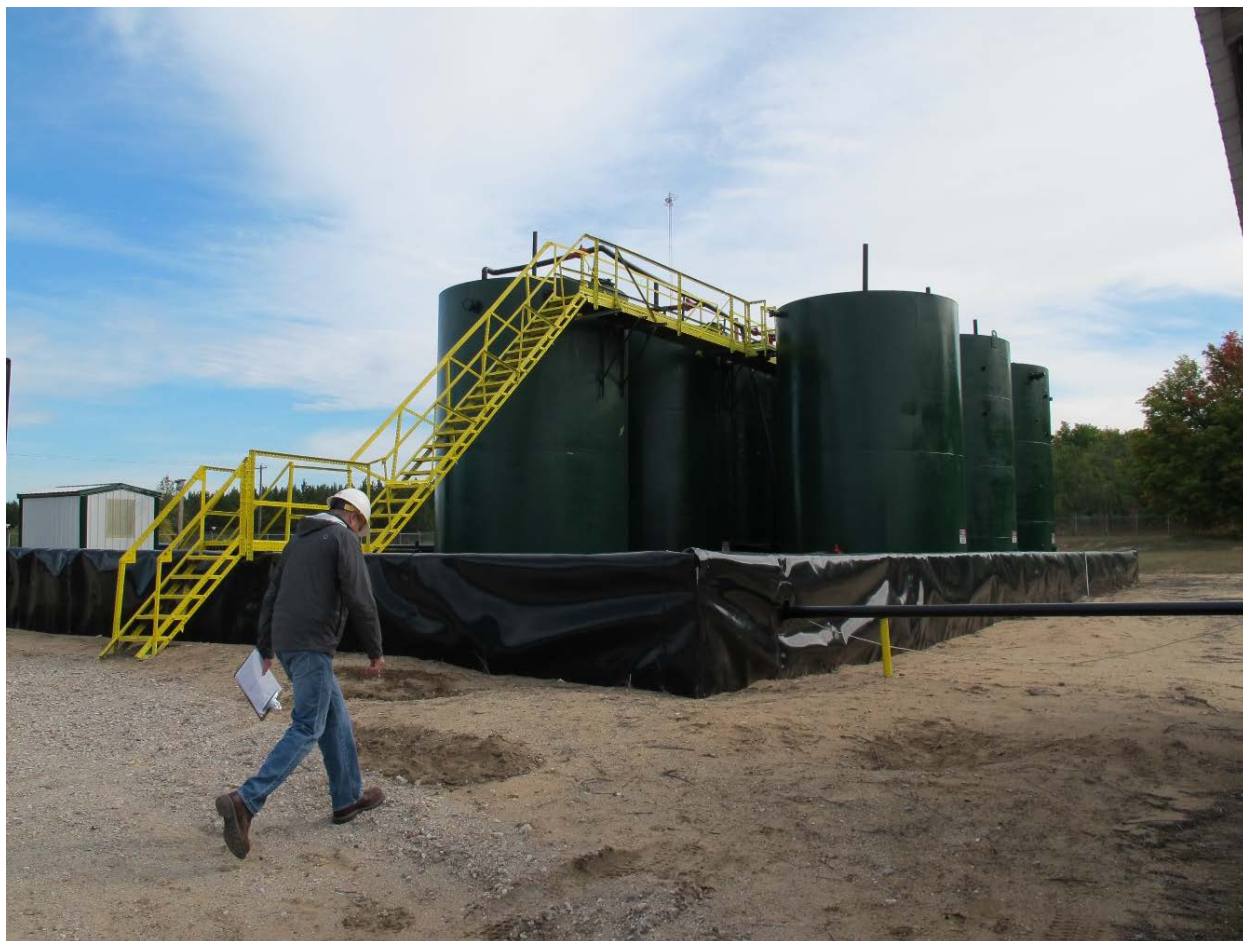
Figure 16: IMG_0275, 9/25/14, 10:49 am (Eastern), Wlosinski #2-27 tank battery and secondary containment area, well pad appeared in good condition, no signs of spills or leaks, EPA Inspector Tim Elkins (center) pictured observing site conditions, facing northeast.

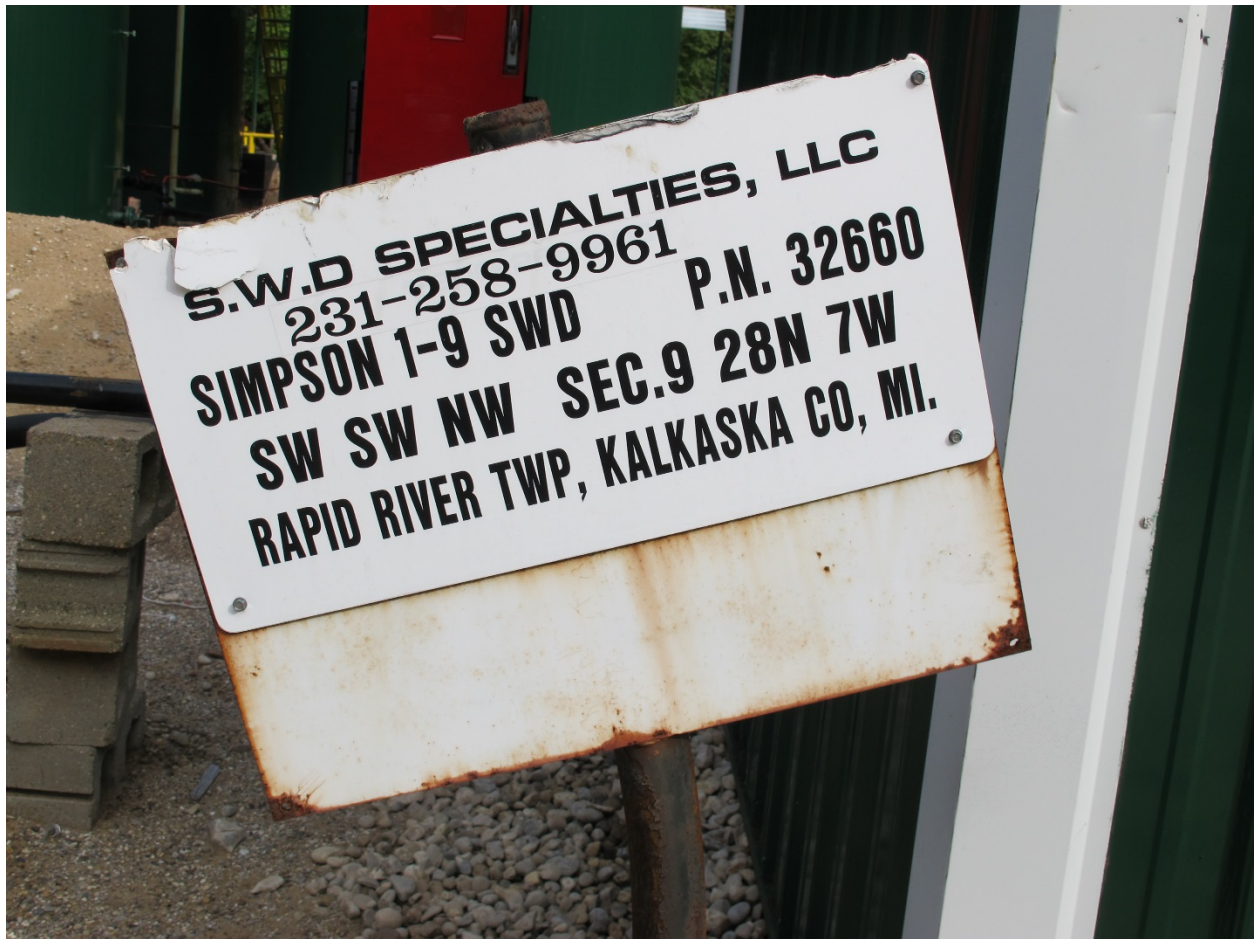
The well pad consists of a sand base, wellhead, pump house, tank battery, and load/off-load station. A sign identifying the well is posted next to the pump house and wellhead (Attachment B, Figures 17 and 24). Gages are present on the tubing and annulus, and appeared to be in good working condition (Attachment B, Figures 18 - 21). EPA observed 30 psig on the tubing, and 1 - 2 psig on the annulus. The annulus to the well is closed, and liquid loss is monitored on a quarterly

Figure 17: IMG_0276, 9/25/14, 11:14 am (Eastern), Simpson #1-9 well sign posted at the facility pump house, facing north.
